# Manhole Inspection Summary

Manhole # S53GG\_005MH

Insp Date: **6/6/08 9:45 AM**

**Location** Address: **Edison**

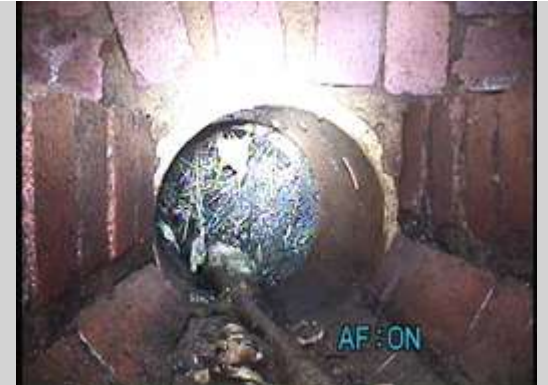
12 O'Clock Outflow

8 in. Circular Gravity Sewer  
Pipe Out @ 12 O'Clock

Pipe Height: **8.4** (in.) Rod and Bar (Angled)  
Pipe Material: **Clay** ☐ Pipe Lined  
Invert Depth: **9.65** (ft.) Flow Characteristics: **Slow**  
Deposits: ☒ None ☐ Mud ☐ Sludge ☐ Debris ☐ Grease  
Silt Depth: (in.) Deposits Extent:  
Infiltration: **None** Pipe Seal Cond: **Sound**

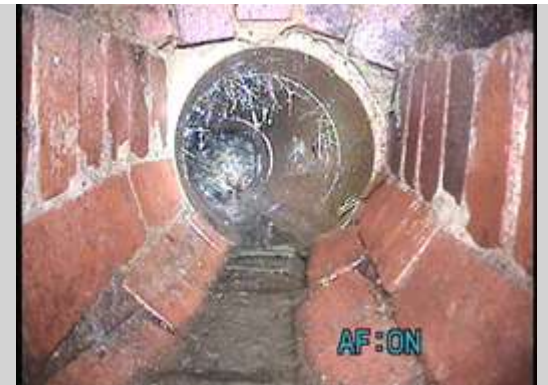
6 O'Clock Inflow

8 in. Circular Gravity Sewer  
Pipe In @ 6 O'Clock

Pipe Height: **8.4** (in.) Rod and Bar (Angled)  
Pipe Material: **Clay** ☐ Pipe Lined  
Invert Depth: **9.50** (ft.) Flow Characteristics: **Slow**  
Deposits: ☒ None ☐ Mud ☐ Sludge ☐ Debris ☐ Grease  
Silt Depth: (in.) Deposits Extent:  
Infiltration: **None** Pipe Seal Cond: **Sound**
